Shannon Bridge Crossing Route Selection Report Volume C - Appendices

APPENDICES

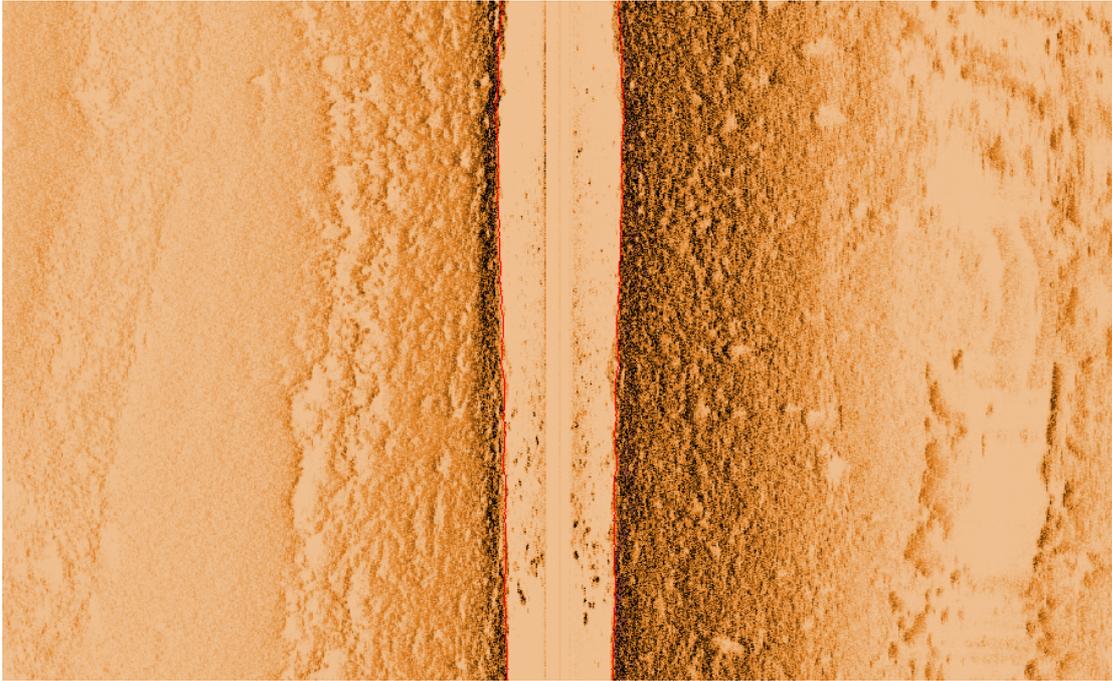
Figure I.3: Sonar Image Displaying the Hard Rock/Gravel Riverbed Within the Study Area.

The substrate at the sites is characterised by high backscatter, uniform tone returns, indicative of a hard gravel or rock riverbed with areas of medium-to-high returns indicate the presence of mixed gravel and sand.

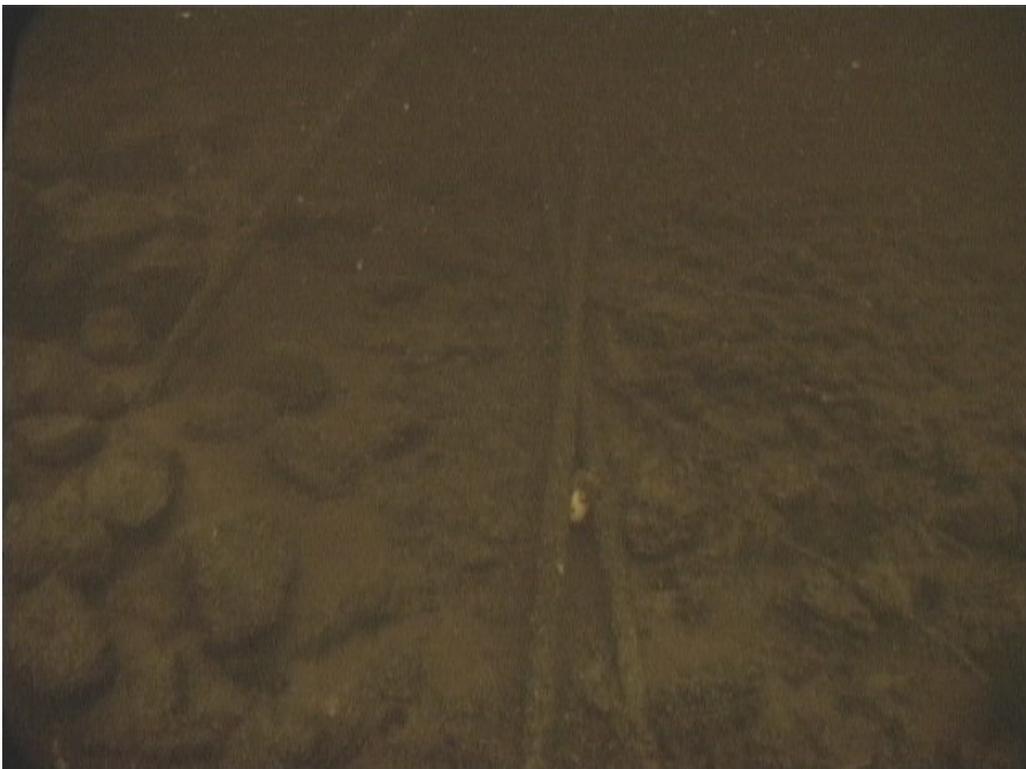
Figure I.22: Anomaly SS1, Collapsed Stone and Slender Wooden Poles

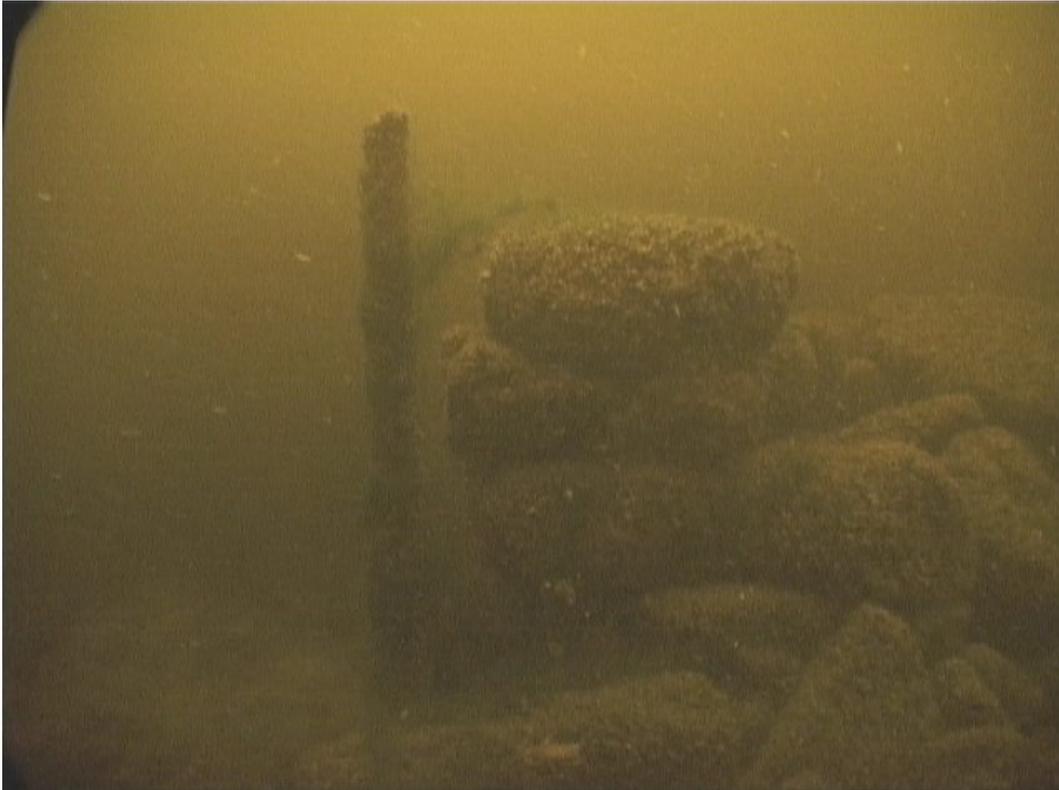
Figure I.23: Anomaly SS1, Upstanding Dry-Stone Wall and Vertical Wooden Post

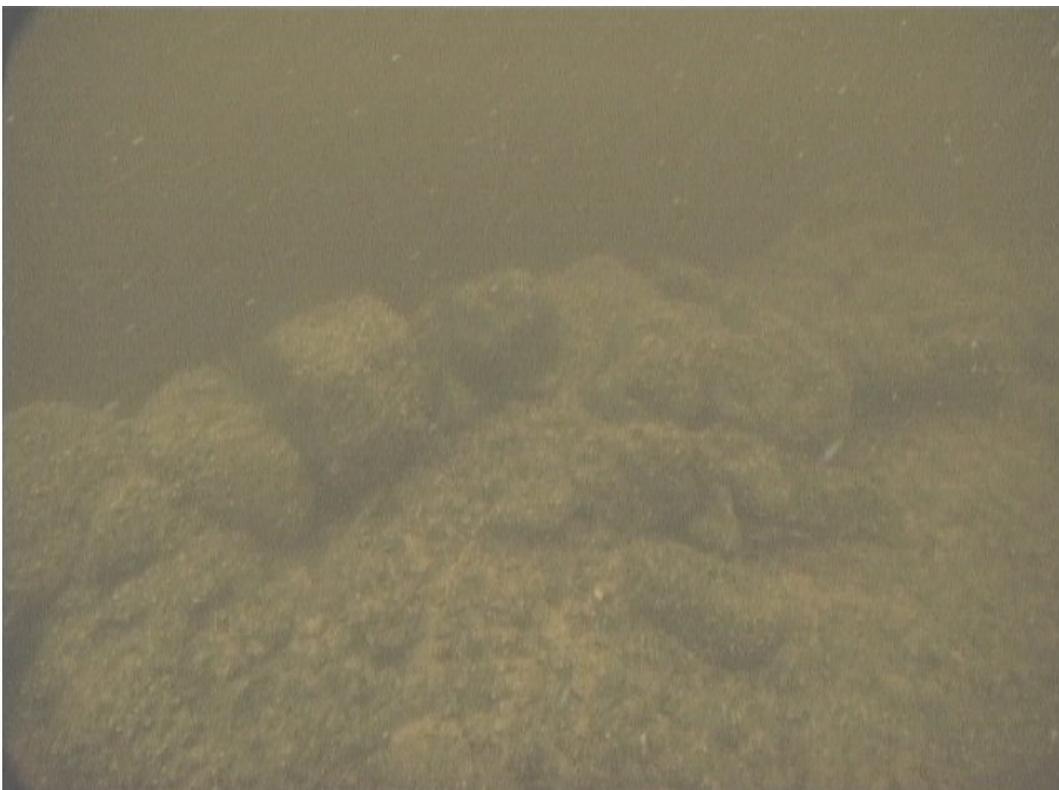
Figure I.24: Anomaly SS2, Area of Collapsed Stone

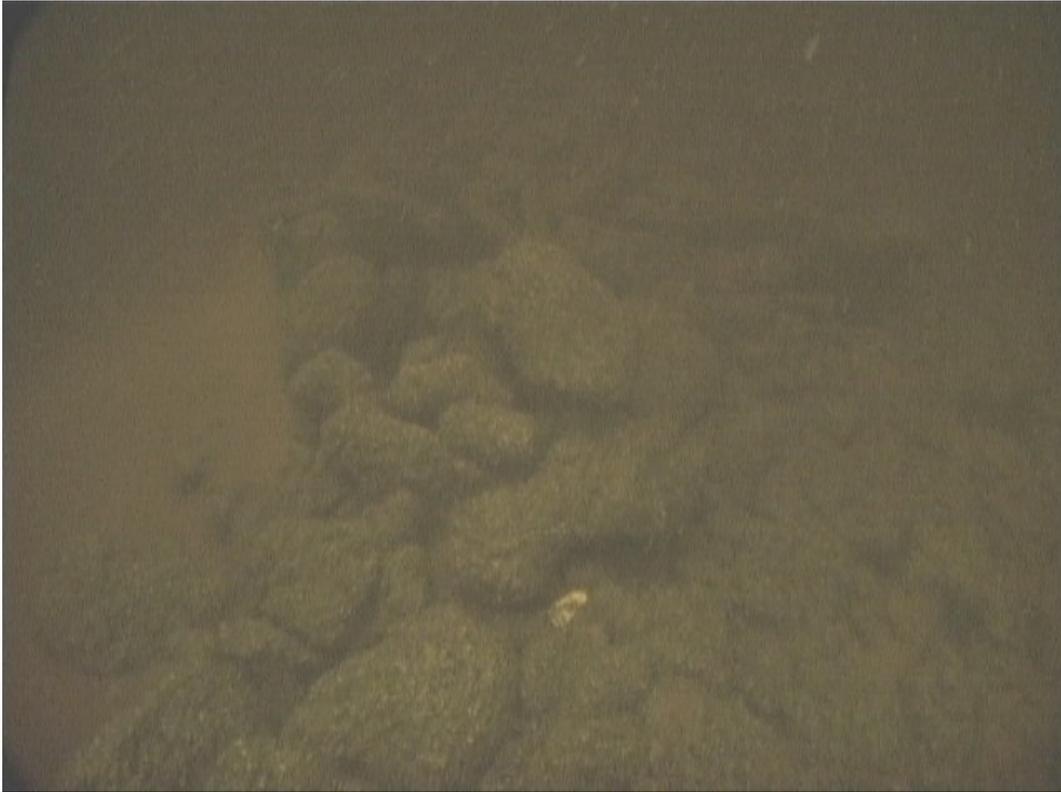
Figure I.25: Anomaly SS2, Area of Collapsed Stone

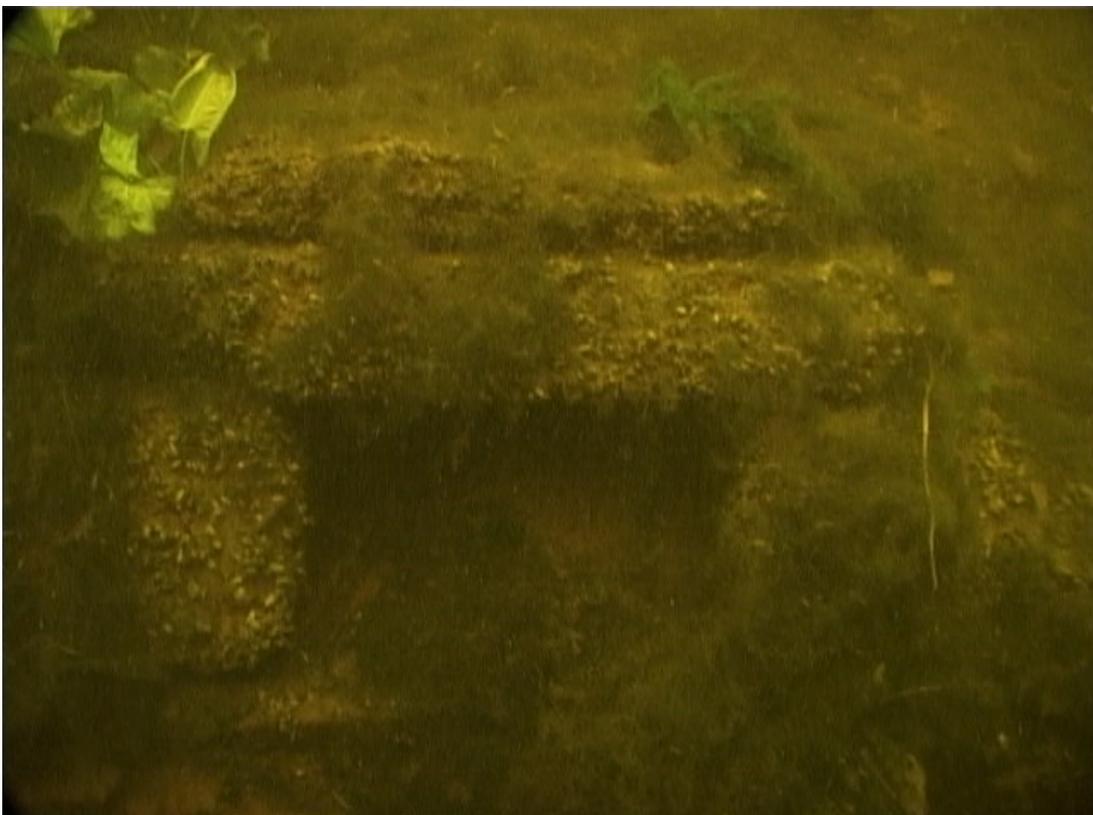
Figure I.28: Dry-Stone Culvert, Possibly a Drainage Channel from the Adjacent Canal
